Cobham SATCOM

Document Number: 95-158413-A

EXPLORER 3075GX/5075GX
SW ver. 1.58 Build 25

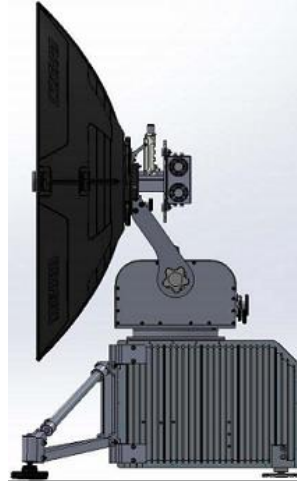
Not supported EXPLORER 3075GX:

EXPLORER 3075GX: This software - including Bootloader upgrade version 1.52 - does **not** support older type of 3075GX (407164A-00500) as some sensors are no longer used. Attempts to upgrade will be rejected with an error / software mismatch message.
