Cobham SATCOM

Document Number: 95-152569-A

EXPLORER® 710
Software release version 1.07

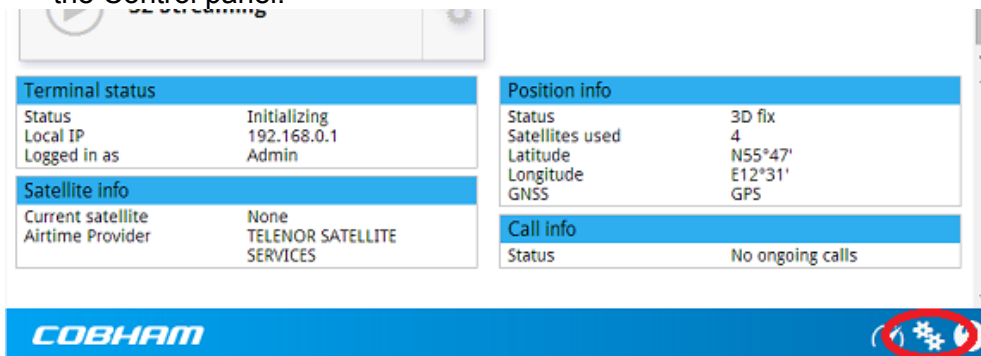
1. Connect external AC/DC adapter.
2. Open the web interface at address <http://192.168.0.1> or <http://ut.bgan> and enter the Control panel.

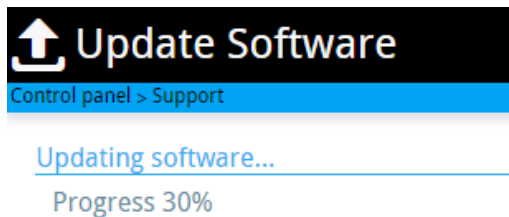
6. Browse to the new software version and click Open. The software file has the extension ".tiif". The EXPLORER 710 will upload the file and start updating the software.

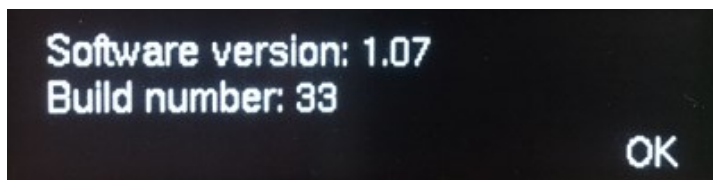
Checking terminal keypad/display for correctly loaded version:

>Properties>Software
