Cobham SATCOM

Document Number: 95-170111-A

EXPLORER 3075GX/5075GX
SW ver. 1.61 Build 14

Please be informed that software, version 1.61 build 14 for the EXPLORER 3075GX - EXPLORER 5075GX has been released.

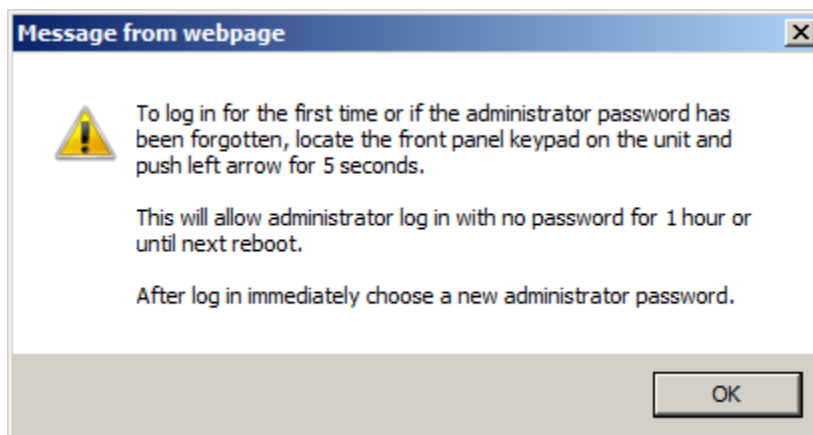
A new link on the login page will display a short help text as below.

- ACU will automatic log out after 1 hour or next reboot.
- Accessing the ACU with 'local administration function' does not change the current admin account password.
- After a factory default reset, the admin password will be disabled and only login using the 'local administration function' will be possible.
- Min length for 'admin' password is 8 characters.
